# What Can We Learn from Safety Incidents?

### **David Lim**

Principal Investigation, Transport Safety Investigation Bureau, Ministry of Transport

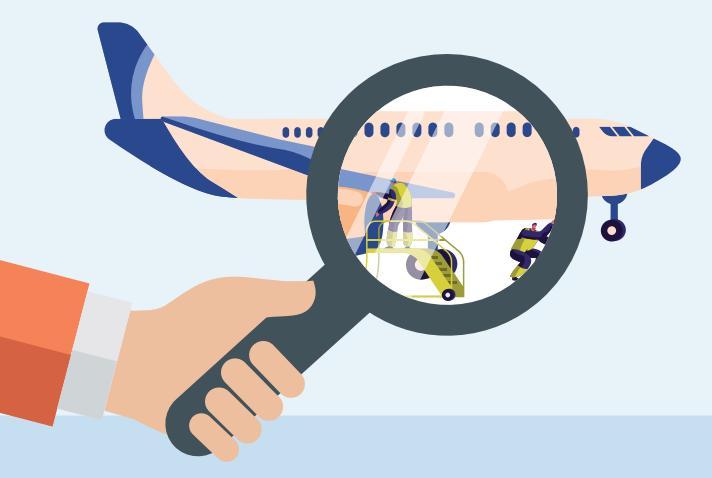
The investigation identified issues pertaining to a lack of maintenance planning, training and control of resources. The smoke and fumes were attributed to an incorrectly performed engine compressor wash procedure carried out by an unqualified maintenance engineer the night before the occurrence. Compressor wash rigs in poor condition; missing records of prior detergent type, concentration and replenishment details; and the non-performance of a key "recommended" step in the engine drying procedure resulted in residual cleaning solution remaining within the aircraft's Environmental Control System, which caused smoke and fumes.

The following changes were made to maintenance procedures and the Engine Service Manual after the accident.

- The tracking of calibration expiry dates of ground support equipment was improved.
- A maintenance planning procedure for resource allocation was introduced prior to start of maintenance.
- Besides identifying training needs of maintenance personnel and providing engineers with additional simulator training on engine ground run, the currency of their skills is actively tracked.
- Before commencing a maintenance task, engineers are given access to correct procedures, records, equipment and tooling, replacement parts and information.
- The engine manufacturer updated its Engine Service Manual to require, rather than only recommend, that a high-power engine dry-out run is conducted after every compressor wash.

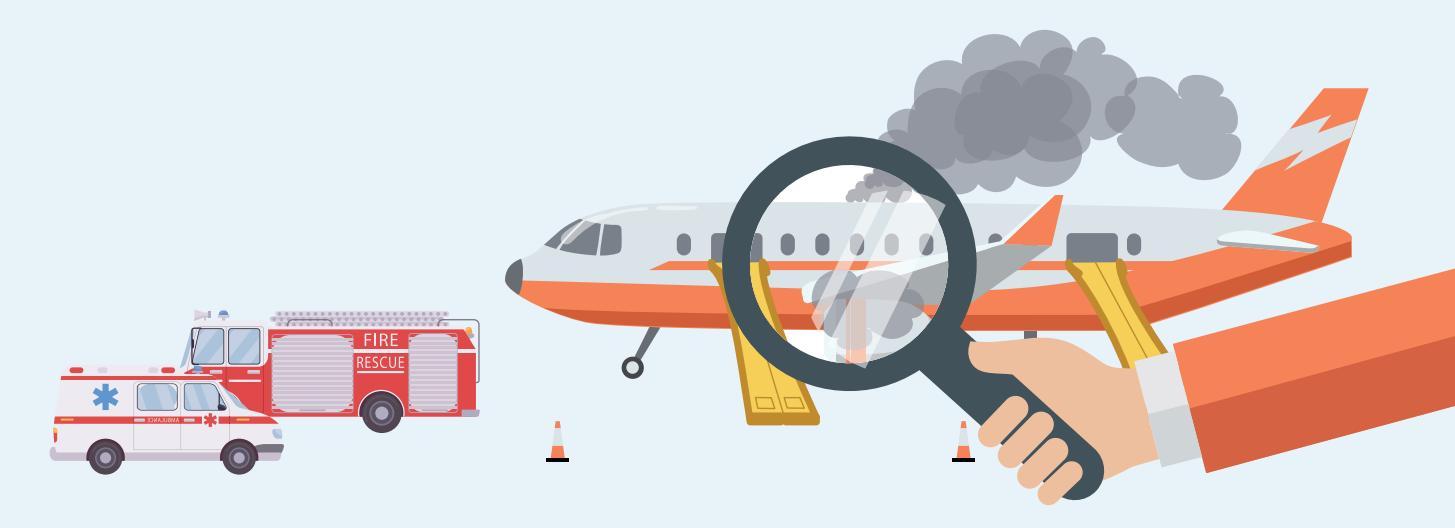
- During the evacuation, passengers who had exited the aircraft via the overwing exits were unsure of how to get down from the wing to the ground. As a result, some of them re-entered the cabin and exited via one of the escape slides. Others jumped down from the wing as they did not know they had to slide off the wing via the trailing edge.
- The flight crew selected flap 5 to allow evacuees to slide down the flap to the ground after they decided to evacuate the aircraft. However, engines were shut down before the flaps travelled to the flap 5 position. This was unanticipated because the flight crew's simulator training for evacuation was based on a rejected take-off where flaps were already set at flap 5 position.

• The rear slides did not round out at the bottom like the front slides. This caused passengers to slide down very fast onto the ground. This, and attempts by passengers to slow themselves down on the slides, were the main causes of injury.

• The operator revised its briefing to passengers seated next to overwing exits. Apart from simplifying the terminology used, these passengers are instructed to be out on the wing first to help direct other passengers. They are also informed that there is no escape slide attached to the overwing exits.

• The UK AAIB recommended to the U.S. Federal Aviation Administration (FAA) and the European Union Aviation Safety Agency (EASA) to review their aircraft certification standards for large transport aircraft, which require the provision of evacuation slides when the emergency egress and escape routes, overwing or otherwise, are 1.8 metres (6 feet) or more above the ground. For lesser heights, passengers are expected to jump down to the ground. However, past safety studies suggested that such jumping can cause injury.
